Models Affected:
Linea -ALL UL/NSF

LINEA(USA) TECHNICAL BULLETIN

January 30, 2001

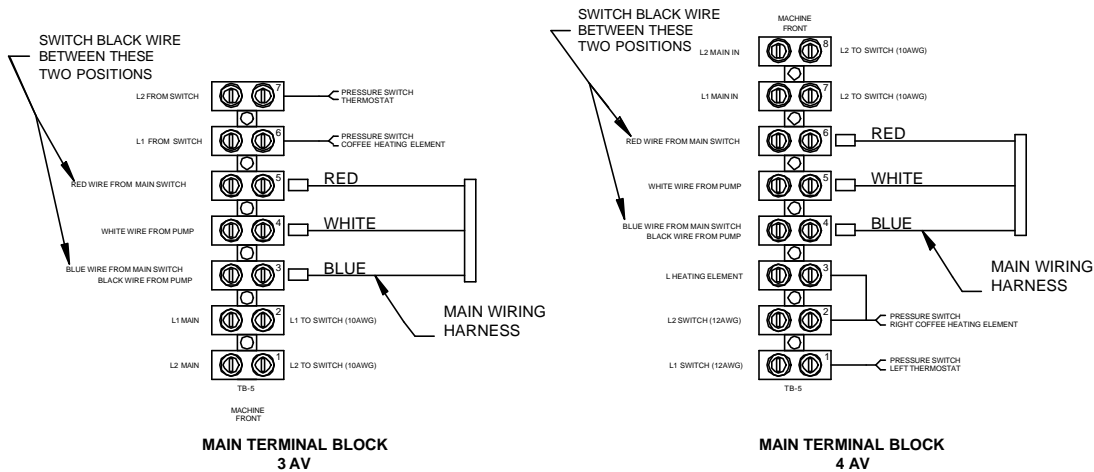
- 1) Pump Motor does not operate when brew cycle is on:
 - a. Ensure that the blue wire from the main switch is connected to the main terminal block opposite the blue wire from the main wiring harness.
 - b. Ensure that the red wire from the main switch is connected to the main terminal block opposite the red wire from the main wiring harness.
 - c. Ensure that the white wire from the pump power cord in connected to the main terminal block opposite the white wire from the main wiring harness.
 - d. The black wire from the pump power cord should be connected to the main terminal block opposite the blue wire from the main wiring harness.

If the pump motor does not operate in this wiring configuration then remove the black wire from the main terminal block and re-connect it to the main terminal block opposite the red wire from the main wiring harness.

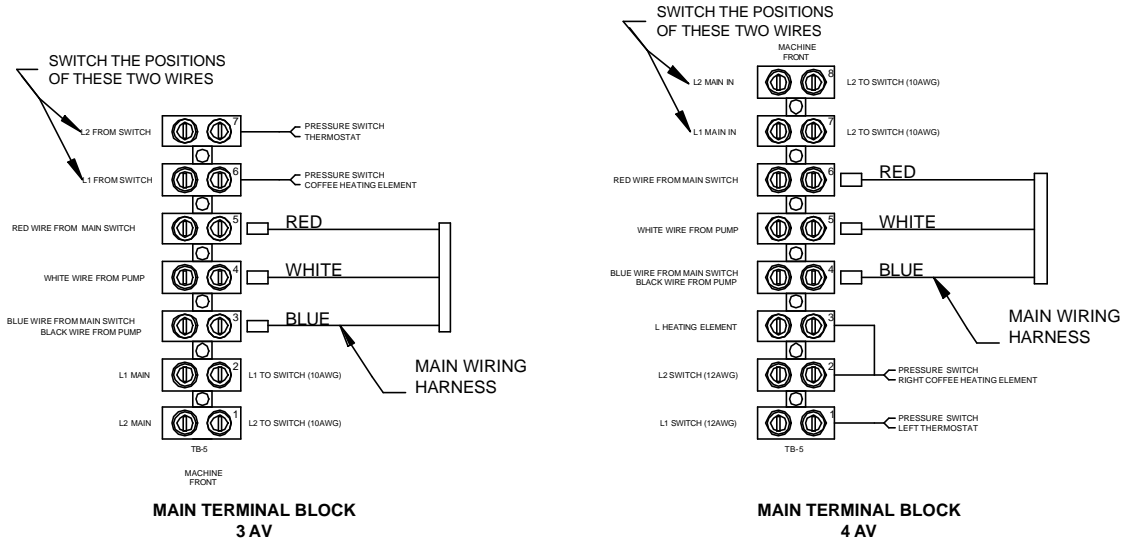
2) The heating cycle indicator lights for the coffee boilers work in reverse, i.e., the indicator light is off during the heating cycle of the coffee boiler and is lighted at the end of the heating cycle

- a. This situation indicates that the current has reversed paths. To correct this problem first locate the two white wires that travel from the main switch to the main terminal block. Switch positions of these two wires at the main terminal block. This will allow the indicator lights to operate properly.
